YOUR ONESURVEY
HOME REPORT

Flat 2 Woodpark
Woodside Avenue
Grantown-on-Spey
PH26 3JR

SINGLE SURVEY

Single Survey

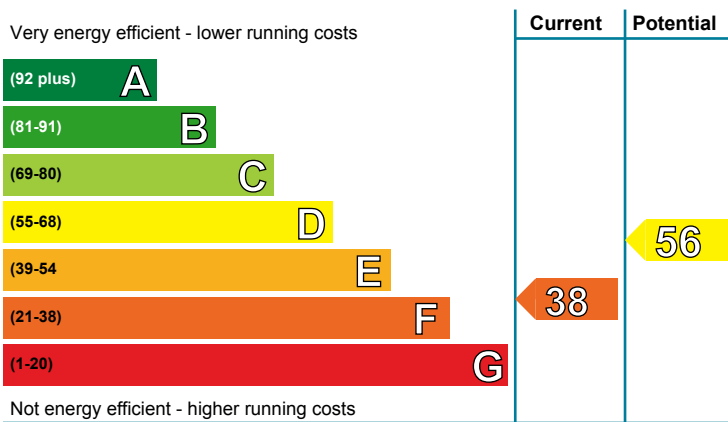
Energy Efficiency Rating

This graph shows the current efficiency of your home, taking into account both energy efficiency and fuel costs. The higher this rating, the lower your fuel bills are likely to be.

Your current rating is **band F (38)**. The average rating for EPCs in Scotland is **band D (61)**.

The potential rating shows the effect of undertaking all of the improvement measures listed within your recommendations report.
